**ASSESSMENT OF ENAMEL LOSS AFTER DEBONDING OF
CERAMIC, COMPOSITE AND METAL BRACKETS-
AN IN VITRO STUDY**

Dissertation Submitted to

MASTER OF DENTAL SURGERY

**BRANCH - V
ORTHODONTICS AND DENTOFACIAL ORTHOPAEDICS
APRIL – 2013**

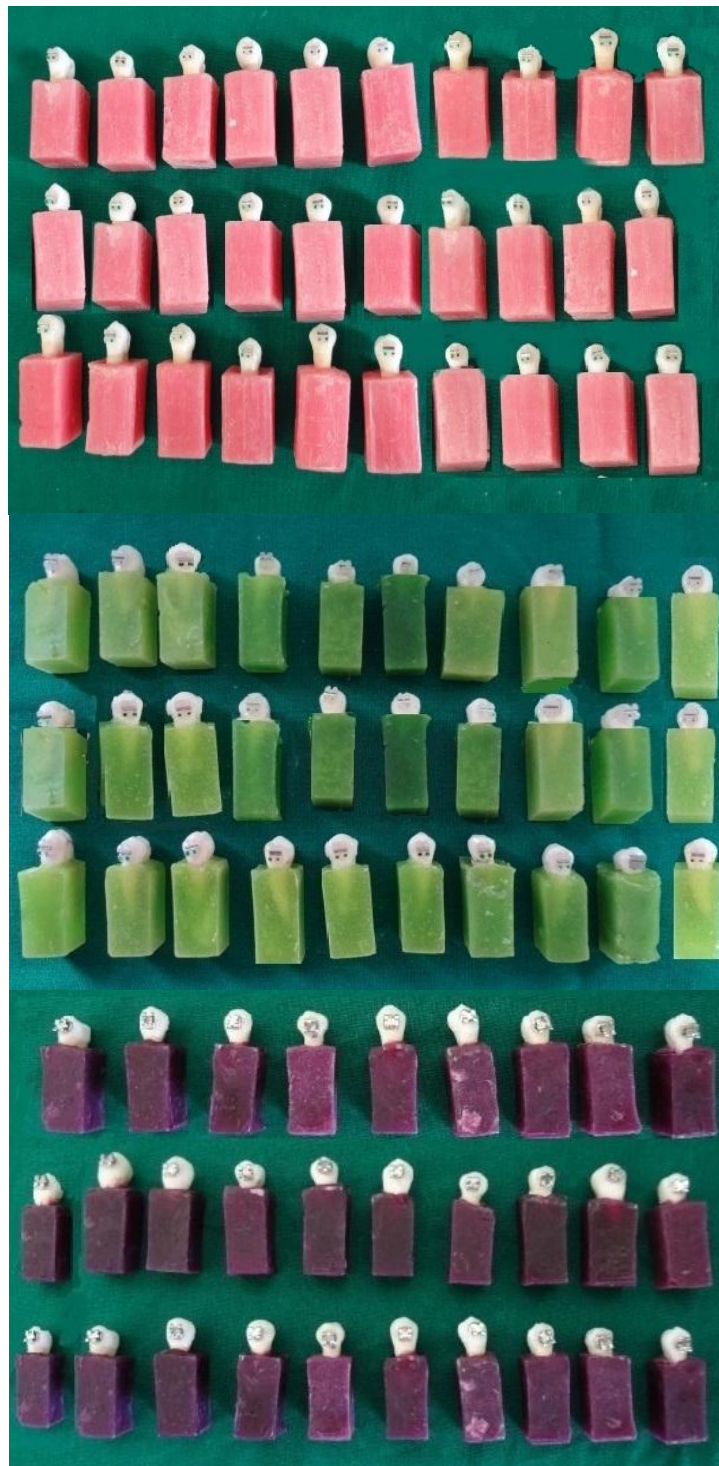
FIGURE 5-BONDED TEETH SAMPLES

PINK-Ceramic bracket

GREEN-Composite Plastic bracket

PURPLE-Stainless steel bracket

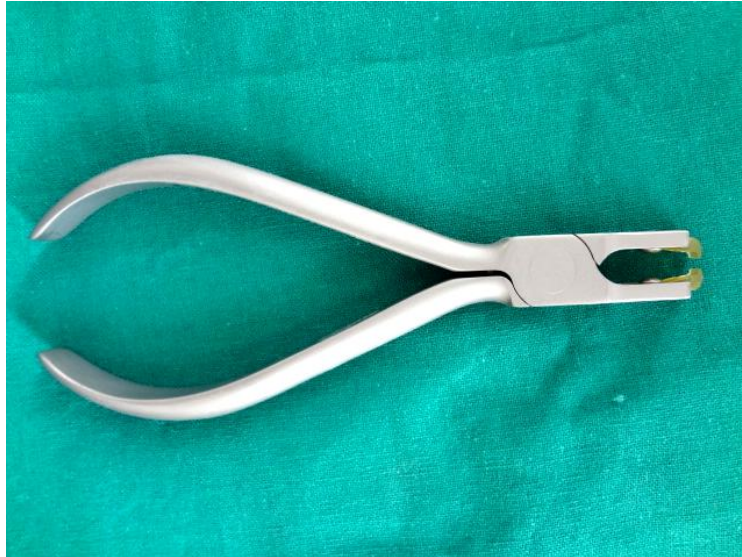
FIGURE 6--#001-343 debonding pliers for ceramic bracket

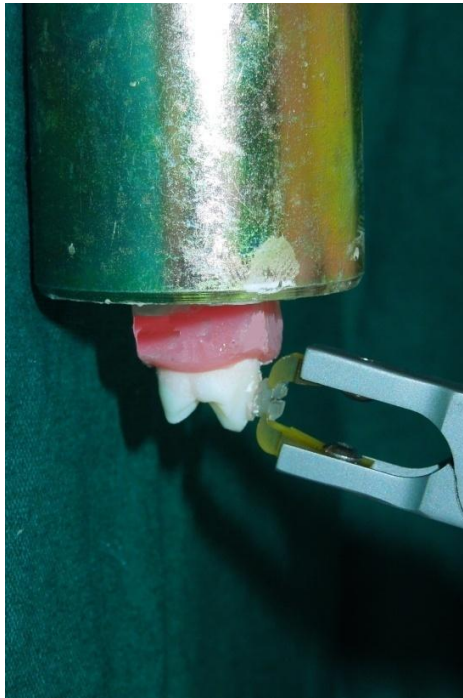
FIGURE 7- Debonding of ceramic bracket

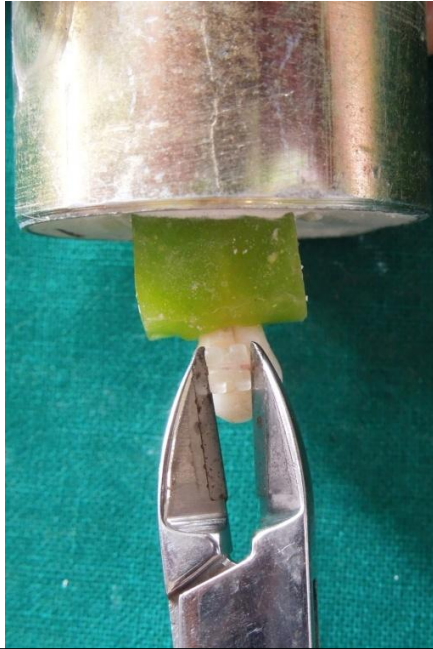
FIGURE 8-Debonding of composite Bracket

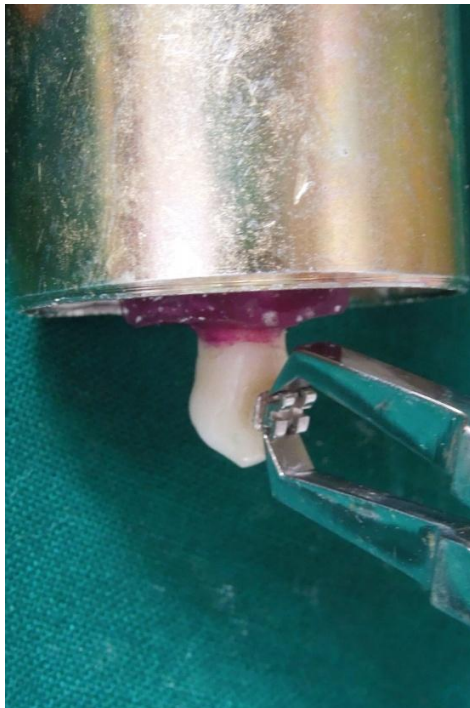
FIGURE 9-Debonding of stainless steel bracket

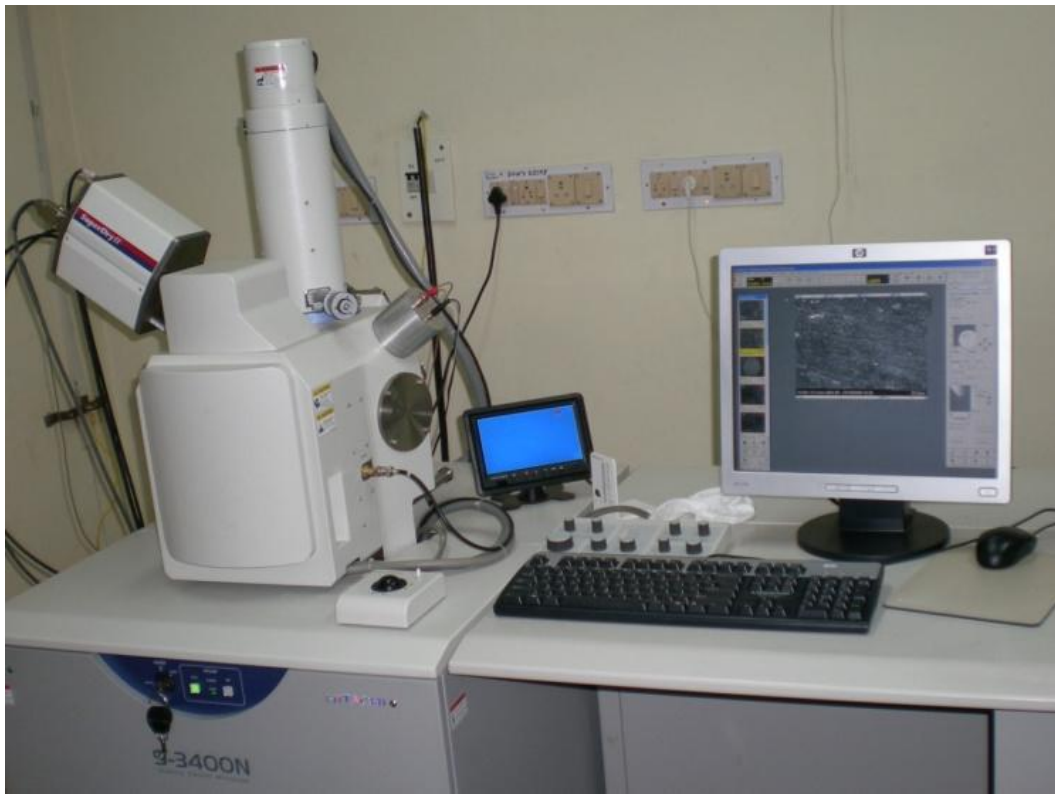
FIGURE 10-SCANNING ELECTRON MICROSCOPE-
Used for examining tooth surfaces after debonding

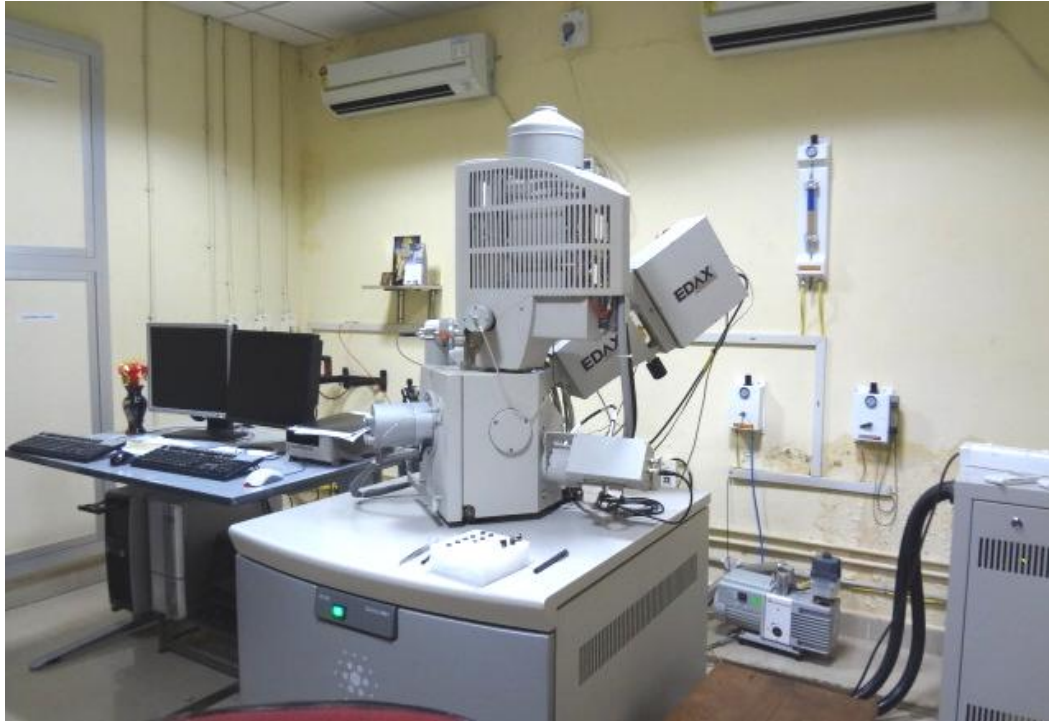
FIGURE 12-Energy dispersive spectroscopy (EDAX^{TSL}-AMETEK,Advanced Micro analysis solutions) attached to FEI Quanta FEG 200-High Resolution Scanning Electron Microscope used for Bracket surface examination after debonding for elemental calcium loss

In addition, energy dispersive spectroscopy (EDAX^{TSL}-AMETEK, Advanced Micro analysis solutions) attached to FEI Quanta FEG 200-High Resolution Scanning Electron Microscope was used to detect calcium (Ca) on the adhesive material removed during debonding of the brackets. Morphologically notable mineral-like particles attached to the adhesive fracture surface as well as the particle-free adhesive fracture surfaces were analysed for their elemental composition by an energy dispersive X-ray microprobe. (Fig 12)
