**COMPARATIVE EVALUATION OF SHEAR BOND
STRENGTH OF VENEERING PORCELAIN TO
BASE METAL ALLOY AND ZIRCONIA
SUBSTRUCTURES BEFORE AND AFTER AGING
– AN IN VITRO STUDY**

Dissertation Submitted to
THE TAMILNADU DR. M.G.R. MEDICAL UNIVERSITY

In partial fulfillment for the Degree of
MASTER OF DENTAL SURGERY

**BRANCH I
PROSTHODONTICS AND CROWN & BRIDGE
APRIL 2011**

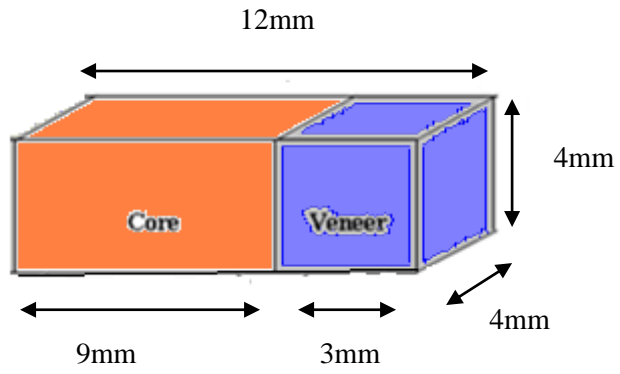
Fig. 1 : Schematic representation of dimension of sample

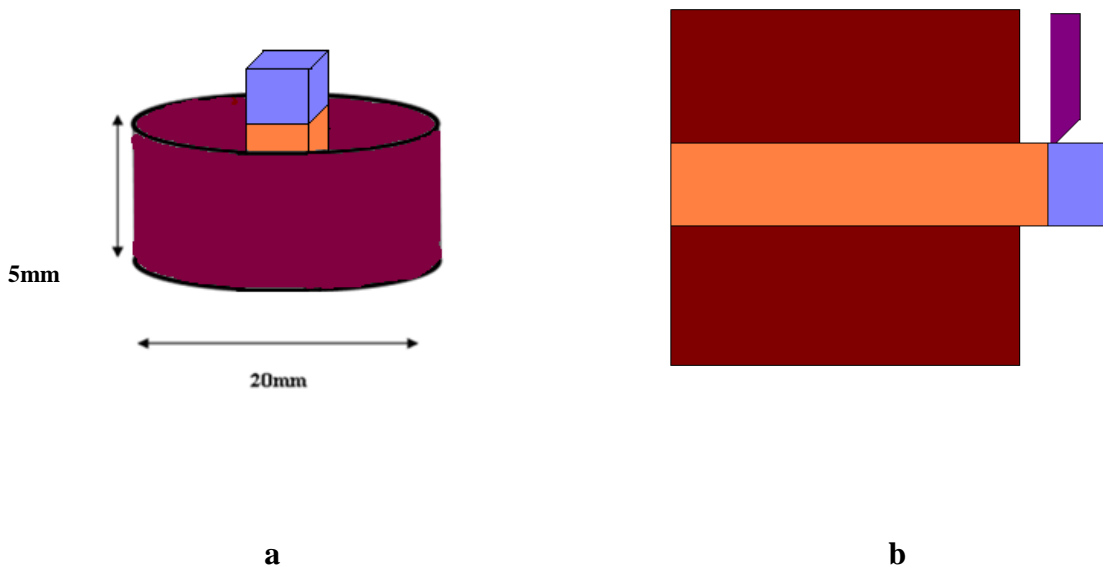
Fig. 2a : Schematic representation of sample embedded in the mold

Fig. 2b : Schematic representation of Shear bond strength testing of sample

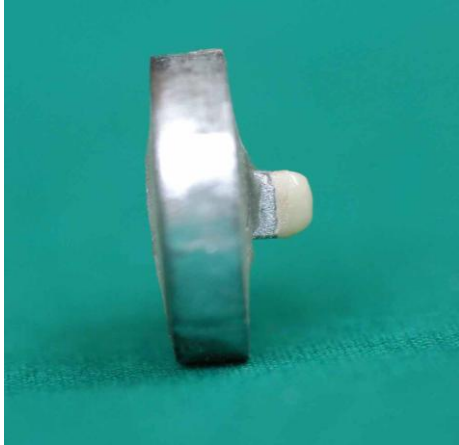
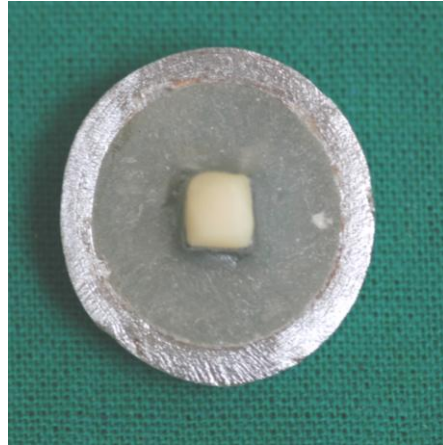
Fig.28: Porcelain veneered base metal alloy Sample embedded in the mold

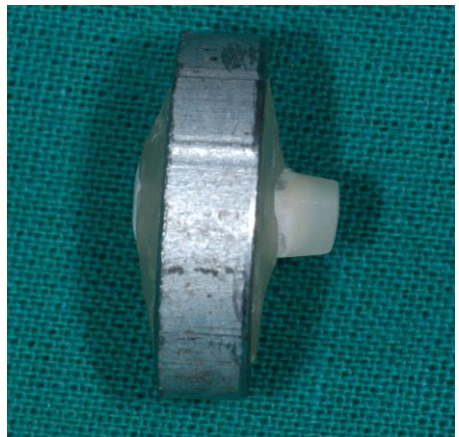
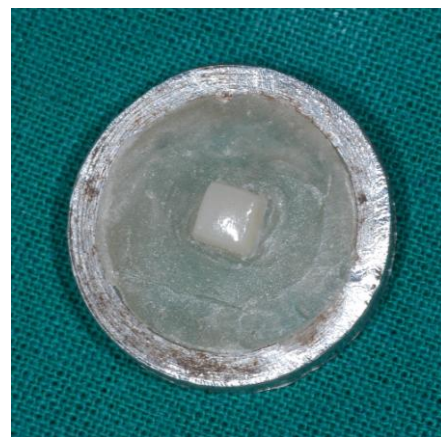
Fig.29: Porcelain veneered Zirconia Sample embedded in the mold

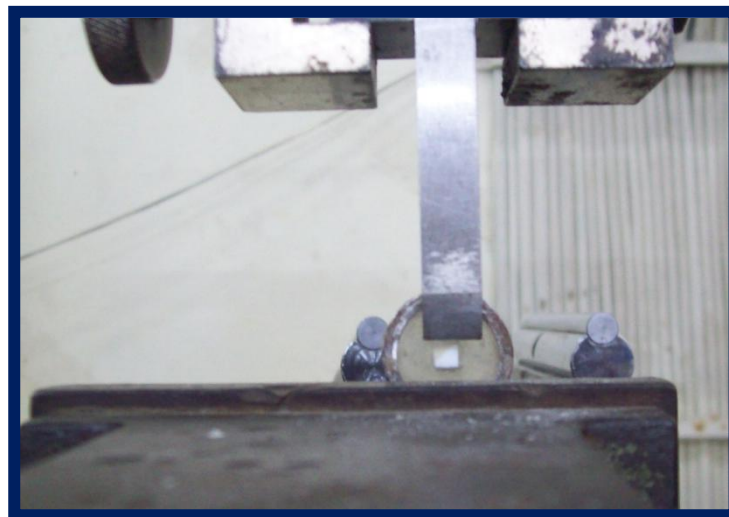
Fig. 31: Sample testing in Universal Testing Machine

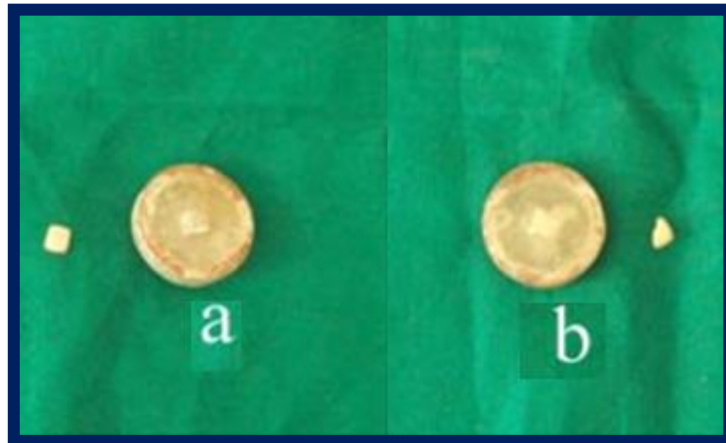
Fig.32 : Samples with fractured piece
a. Porcelain veneered base metal alloy sample with fractured piece
b. Porcelain veneered Zirconia sample with fractured piece

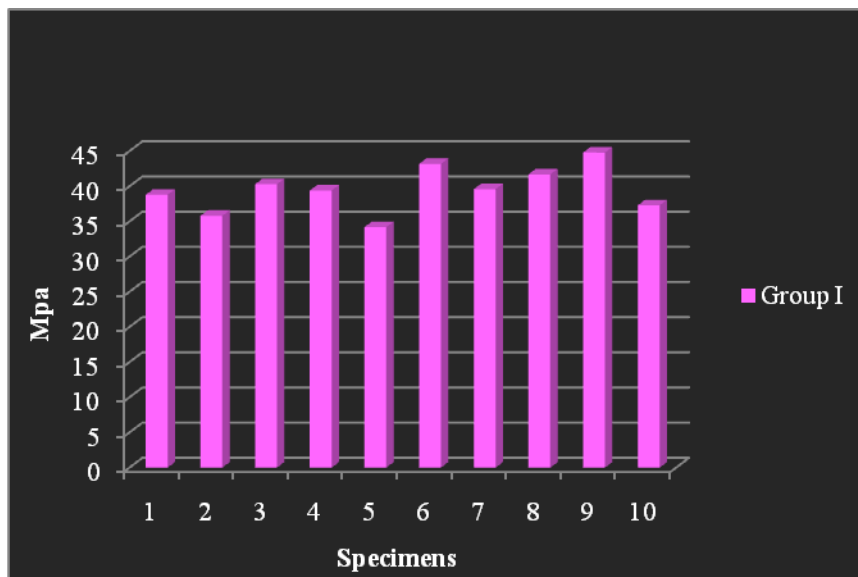
Graph :1

Basic values of shear bond strength of veneering porcelain to base metal alloy substructure before aging (Group I)

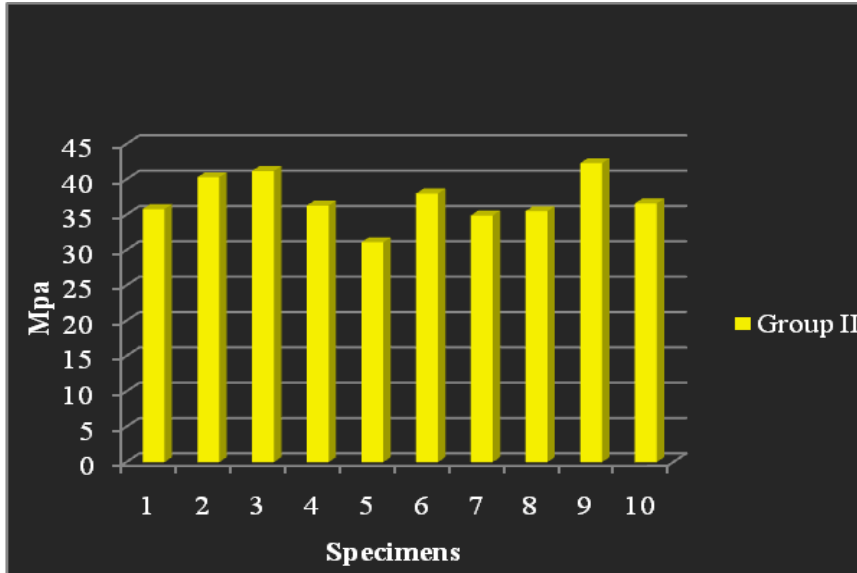
Graph :2

Basic values of shear bond strength of veneering porcelain to base metal alloy substructure after aging (Group II)

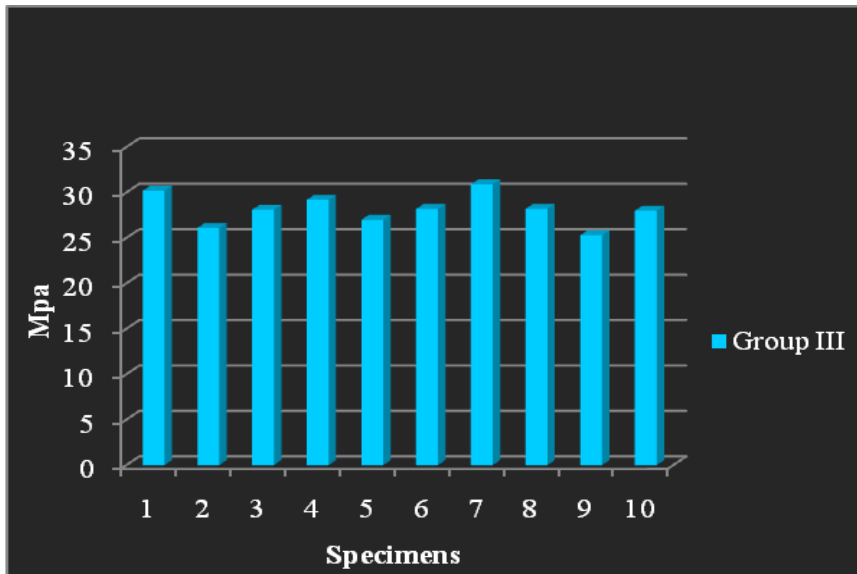
Graph :3

Basic values of shear bond strength of veneering porcelain to zirconia substructure before aging (Group III)

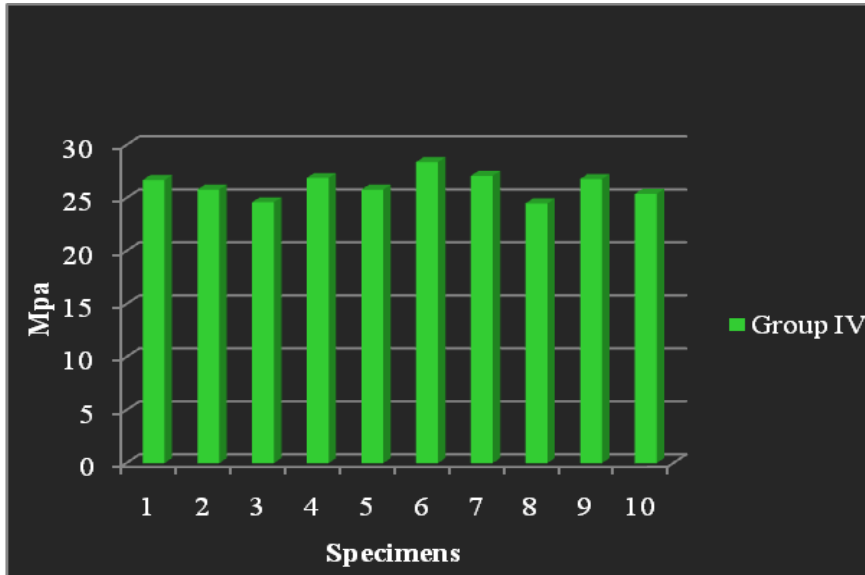
Graph :4

Basic values of shear bond strength of veneering porcelain to zirconia substructure after aging (Group IV)

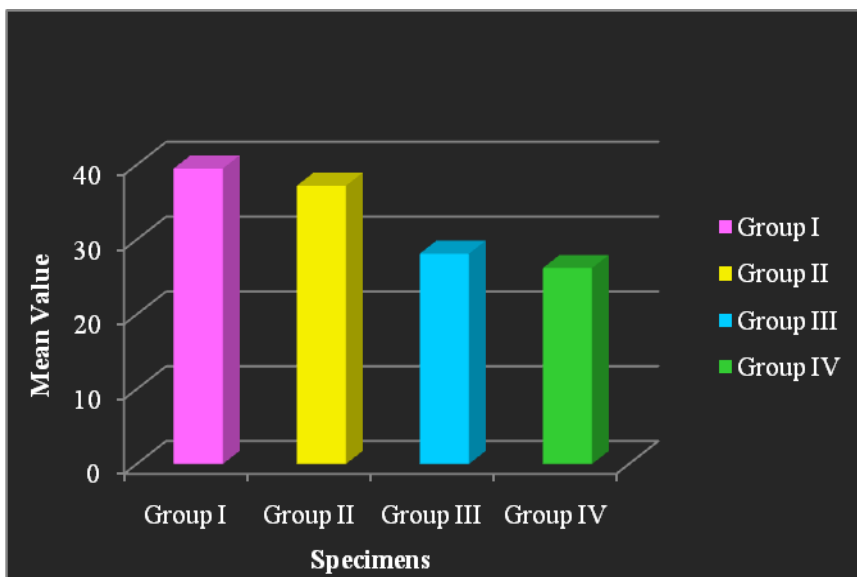
Graph :5

Comparison of mean shear bond strength obtained from basic values of four groups (Group I, II, III & IV)

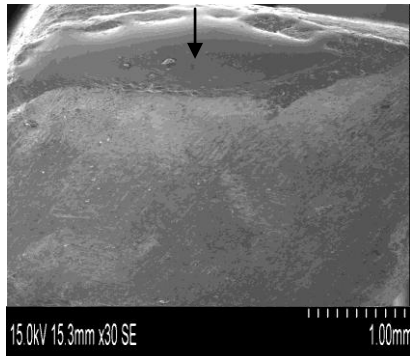
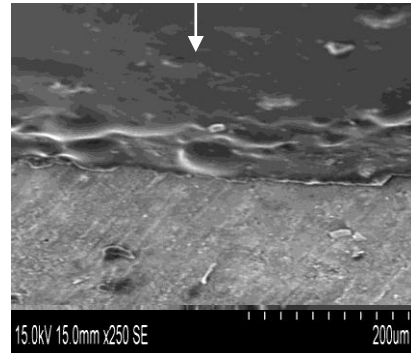
Fig. 34 a : Tested porcelain veneered base metal alloy sample before aging under 30x magnification

Fig. 34 b : Tested porcelain veneered base metal alloy sample before aging, under 250x magnification

Note : The Arrow indicates the direction of load.

Inference (Group I) : The arrow indicated the direction of load. The loaded side demonstrated predominantly cohesive failure within the veneering porcelain. 30x magnification of base metal alloy sample before aging (Fig.34a) revealed a combination of cohesive failure of veneering ceramic and cohesive failure of metal oxide. 250x magnification of fractured core surface (fig.34b) showed numerous pores within the veneering porcelain and in the metal oxide layer. 30x magnification (Fig.34c) of fractured veneer surface revealed the presence of metal oxide and the ceramic material. 250x magnification (Fig.34d) of fractured veneer surface revealed numerous pores within the ceramic and also in the metal oxide. Chemical composition of the fractured core surface and the fractured veneer surface were analyzed using energy dispersive X-ray microanalysis (EDX analysis). Surface chemistry of the fractured core surface (Graph:6) explained the elements seen on the surface of fractured core and revealed the presence of silica, alumina, sodium, potassium, chromium, nickel, oxygen and carbon . The total count of silica was found to be higher indicating predominantly cohesive failure of veneering ceramic. Surface chemistry of fractured veneer surface (Graph:7) revealed the presence of silica, alumina, sodium, potassium, chromium, nickel, oxygen and carbon. Since the silica content was higher, the surface chemistry indicated predominantly cohesive failure of veneering porcelain. Graphical representation of surface chemistry was presented along with SEM images of corresponding samples.

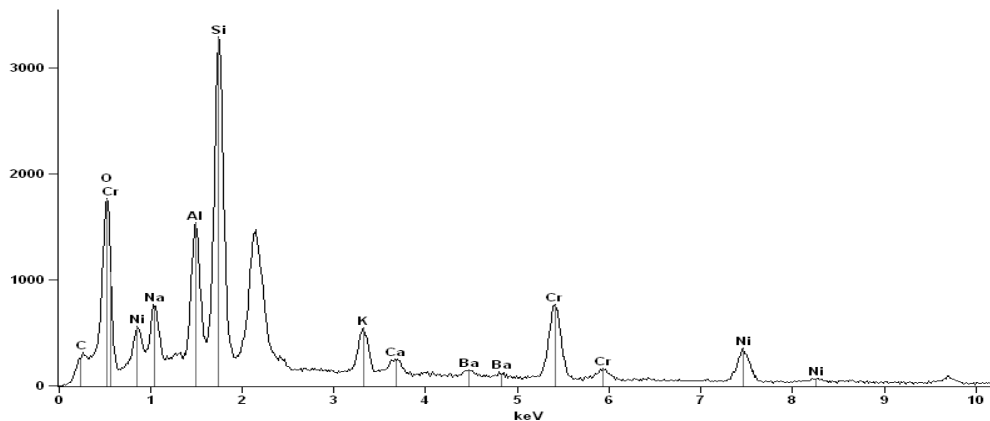
Graph:6 Energy Dispersive X– ray microanalysis of fractured interface of the core surface (Group I)

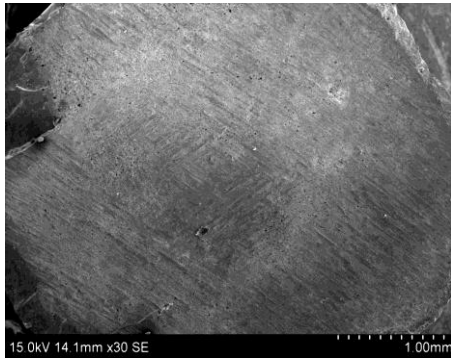
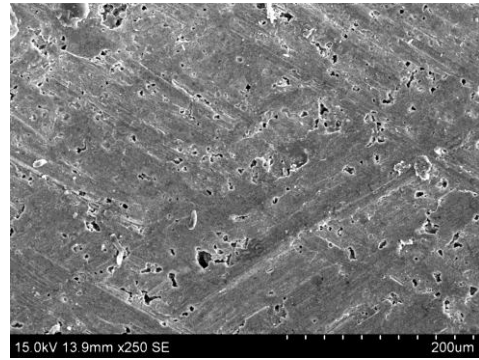
Fig. 34 c : Fractured veneer surface (Group I), under 30x magnification

Fig. 34 d : Fractured veneer surface (Group I), under 250x magnification

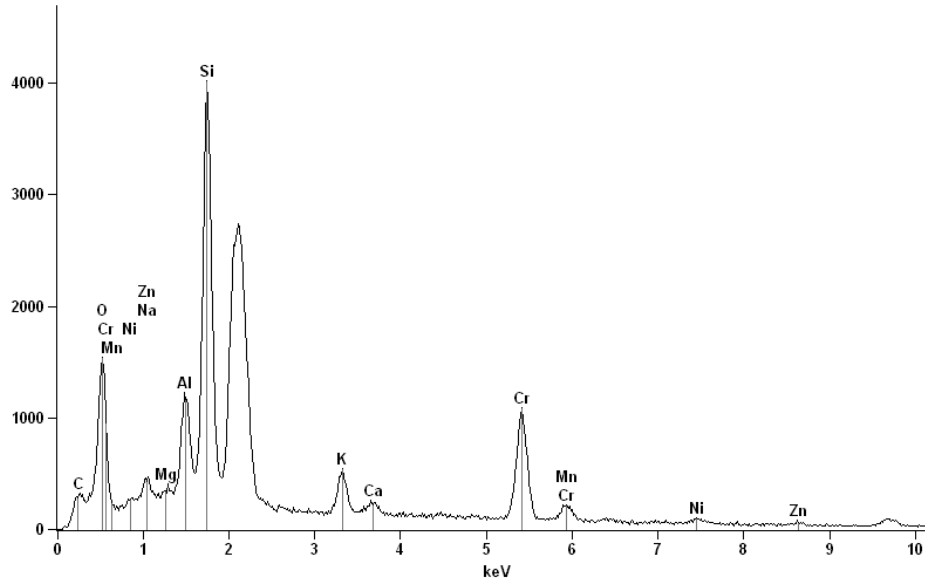
Graph :7 Energy Dispersive X– ray microanalysis of fractured veneer surface (Group I)

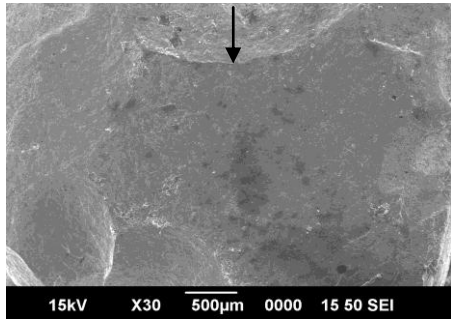
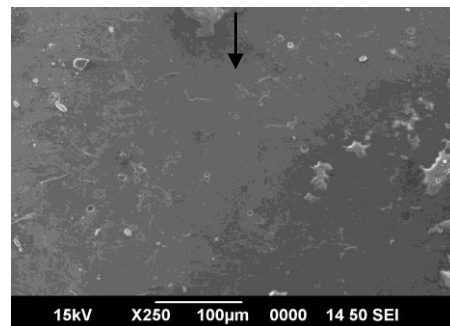
Fig. 35 a : Tested porcelain veneered base metal alloy sample after aging, under 30x magnification

Fig. 35 b : Tested porcelain veneered base metal alloy sample after aging, under 250x magnification

Note : The Arrow indicates the direction of load.

Inference (Group II) : The arrow indicated the direction of load. The loaded side demonstrated cohesive failure within the veneering ceramic. 30x magnification of tested base metal alloy samples after aging (Fig.35a) showed a cohesive failure of veneering ceramic. Higher magnification (250x) (Fig.35b) showed small pores in the veneering ceramic layer over the base metal alloy surface. 30x (Fig.35c) and 250x (Fig.35d) magnification of fractured veneer surface showed numerous pores within the veneering ceramic. Chemical composition of the fractured core surface and the fractured veneer surface were analyzed using energy dispersive X-ray microanalysis (EDX analysis). Surface chemistry of the fractured core surface (Graph:8) explained the elements seen on the surface of fractured core and revealed the presence of silica, alumina, sodium, potassium, oxygen and carbon . The elements seen over the fractured core surface indicated cohesive failure of veneering ceramic. Surface chemistry of fractured veneer surface (Graph:9) revealed the presence of silica, alumina, sodium, potassium, oxygen and carbon. Elements which were presented over the fractured veneer surface indicated cohesive failure of veneering ceramic. Graphical representation of surface chemistry was presented along with SEM images of corresponding samples.

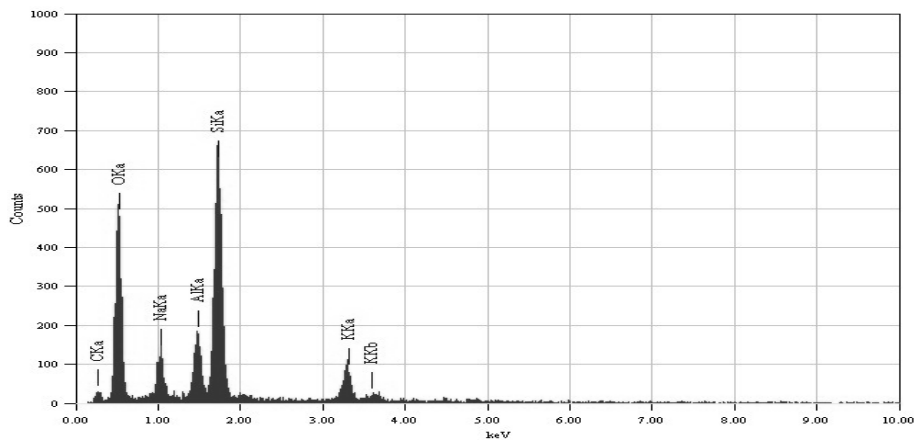
Graph :8 Energy Dispersive X – ray microanalysis of fractured interface of the core surface (Group II)

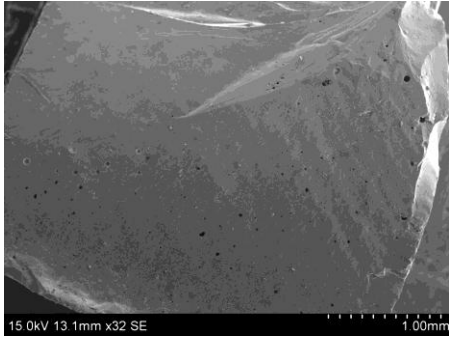
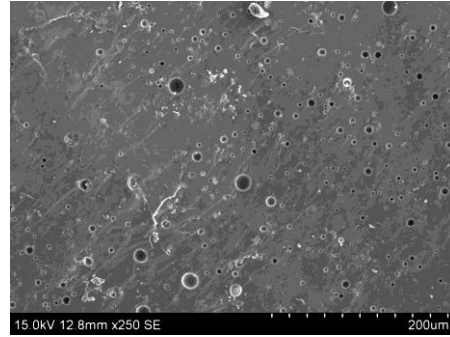
Fig. 35 c : Fractured veneer surface (Group II), under 30x magnification

Fig. 35 d : Fractured veneer surface (Group II), under 250x magnification

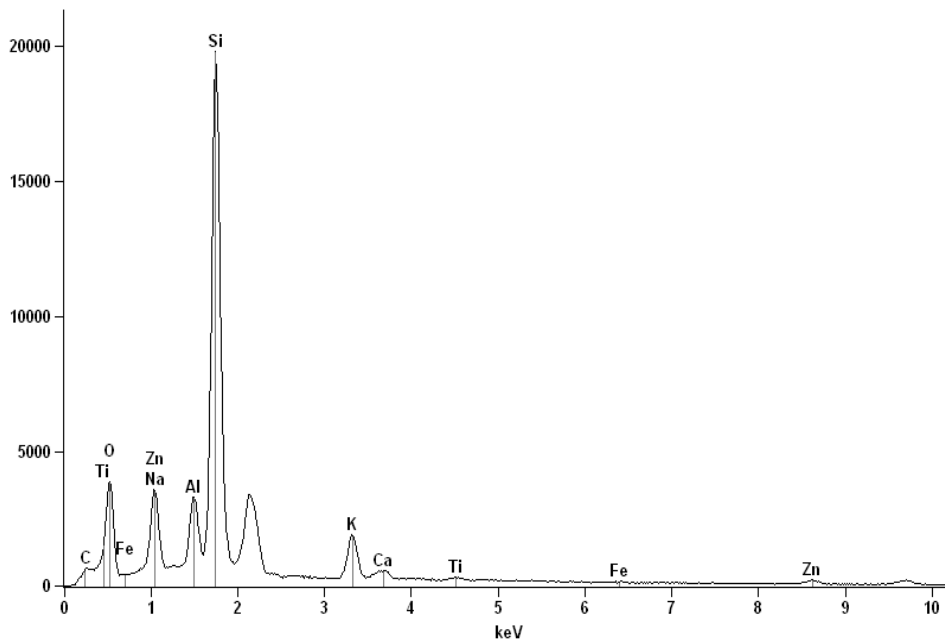
Graph :9 Energy Dispersive X– ray microanalysis of fractured veneer surface (Group II)

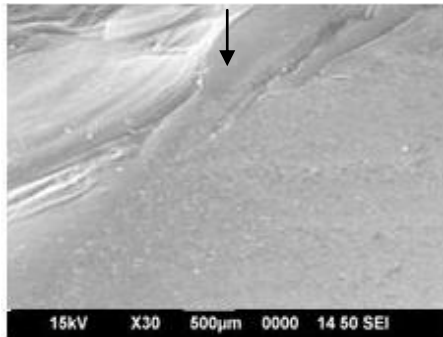
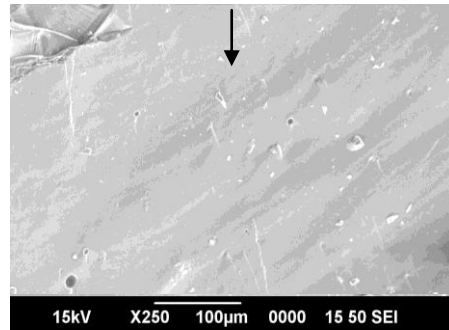
Fig. 36 a : Tested porcelain veneered zirconia sample before aging, under 30x magnification

Fig. 36 b : Tested porcelain veneered zirconia sample before aging, under 250x magnification

Note : The Arrow indicates the direction of load.

Inference (Group III) : The arrow indicated the direction of load. The loaded side demonstrated cohesive failure within the veneering ceramic. 30x magnification of tested zirconia samples before aging (Fig.36a) revealed a mixed cohesive and adhesive failure of veneering ceramic, predominantly cohesive failure of veneering ceramic exposing zirconia core in some areas. Higher magnification (250x) (Fig.36b) showed small pores within the veneering ceramic. 30x (Fig36c) and 250x (Fig36d) magnification of fractured veneering ceramic surface revealed numerous pores within the veneering ceramic. Chemical composition of the fractured core surface and the fractured veneer surface were analyzed using energy dispersive X-ray microanalysis (EDX analysis). Surface chemistry of the fractured core surface (Graph:10) explained the elements seen on the surface of fractured core and revealed the presence of silica, alumina, sodium, potassium, oxygen, carbon and zirconia . The elements seen over the fractured core surface indicated mixed cohesive and adhesive failure of veneering ceramic exposing some areas of zirconia core. Since the silica content was higher, the surface chemistry indicated predominantly cohesive failure of veneering ceramic. Surface chemistry of fractured veneer surface (Graph:11) revealed the presence of silica, alumina, sodium, potassium, oxygen , carbon, zinc and titanium.. Elements which were presented over the fractured veneer surface indicated predominantly cohesive failure of veneering ceramic. Graphical representation of surface chemistry was presented along with SEM images of corresponding samples.

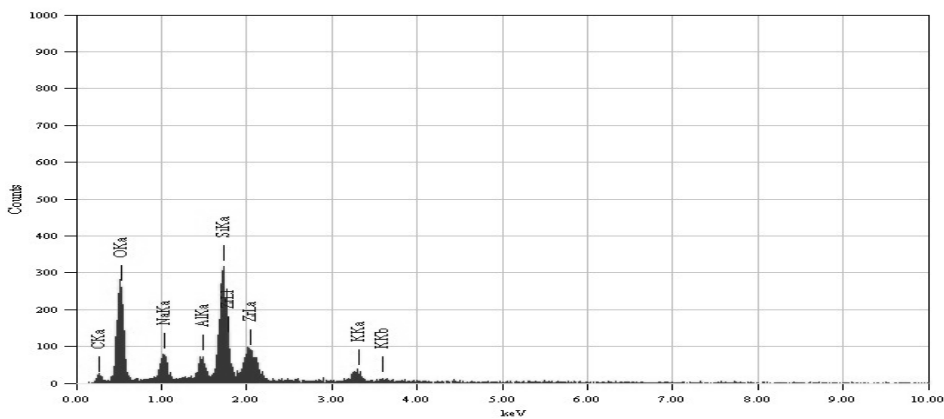
Graph :10 Energy Dispersive X – ray microanalysis of fractured interface of the core surface (Group III)

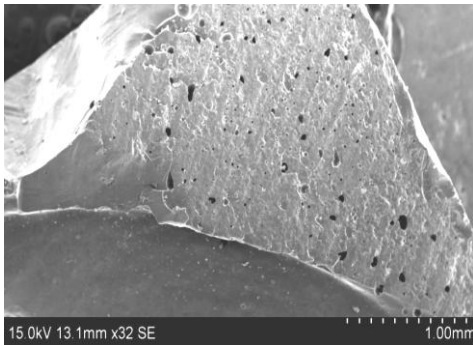
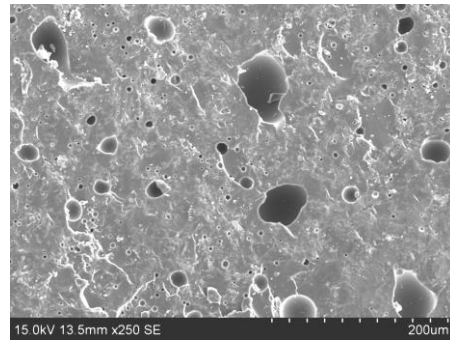
Fig. 36 c : Fractured veneer surface (Group III), under 30x magnification

Fig. 36 d : Fractured veneer surface (Group III),under 250x magnification

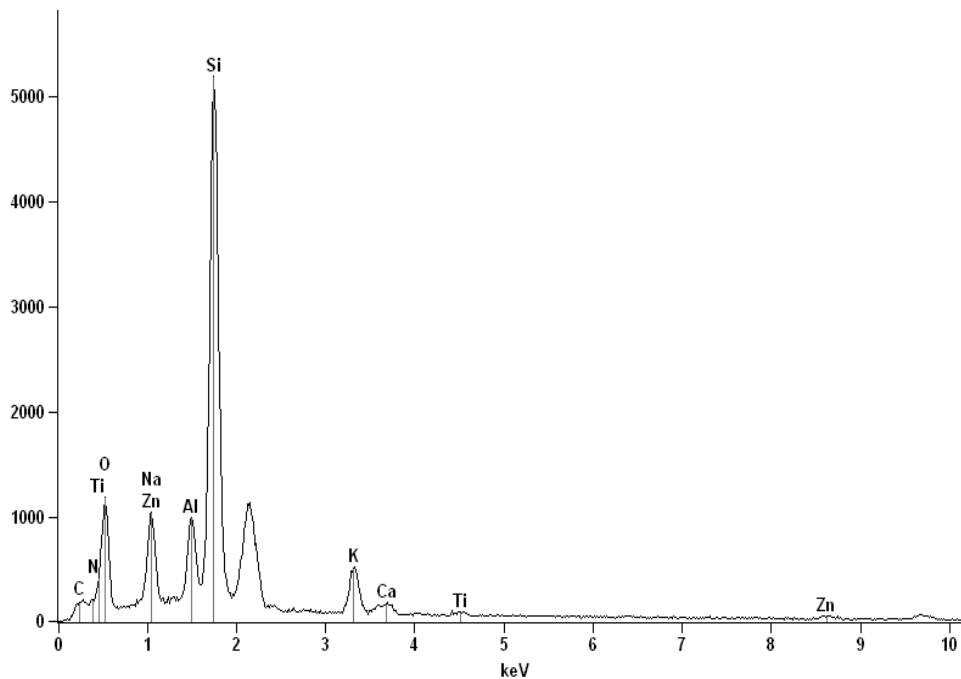
Graph :11 Energy Dispersive X– ray microanalysis of fractured veneer surface (Group III)

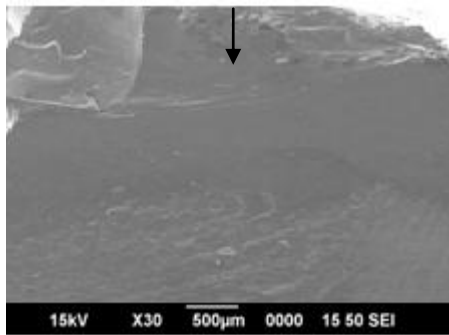
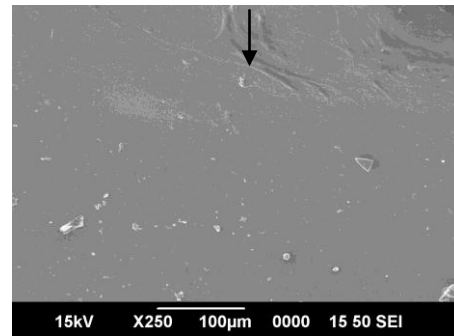
Fig. 37 a : Tested porcelain veneered zirconia sample after aging, under 30x magnification

Fig. 37 b : Tested porcelain veneered zirconia sample after aging, under 250x magnification

Note : The Arrow indicates the direction of load.

Inference (Group IV) : The arrow indicated the direction of load. The loaded side demonstrated cohesive failure within the veneering ceramic. 30x magnification of tested zirconia samples after aging (Fig.37a) revealed a mixed cohesive and adhesive failure of veneering ceramic, predominantly cohesive failure of veneering ceramic exposing zirconia core in some areas. Higher magnification (250x) (Fig.37b) showed small pores within the veneering ceramic. 30x (Fig37c) and 250x (Fig37d) magnification of fractured veneering ceramic surface revealed numerous pores within the veneering ceramic. Chemical composition of the fractured core surface and the fractured veneer surface were analyzed using energy dispersive X-ray microanalysis (EDX analysis). Surface chemistry of the fractured core surface (Graph:12) explained the elements seen on the surface of fractured core and revealed the presence of silica, alumina, sodium, potassium, oxygen, carbon and zirconia . The elements seen over the fractured core surface indicated mixed cohesive and adhesive failure of veneering ceramic exposing some areas of zirconia core. Since the silica content was more, the surface chemistry indicated predominantly cohesive failure of veneering ceramic. Surface chemistry of fractured veneer surface (Graph:13) revealed the presence of silica, alumina, sodium, potassium, magnesium, iron, oxygen , carbon and calcium. Elements which were presented over the fractured veneer surface indicated predominantly cohesive failure of veneering ceramic. Graphical representation of surface chemistry was presented along with SEM images of corresponding samples.

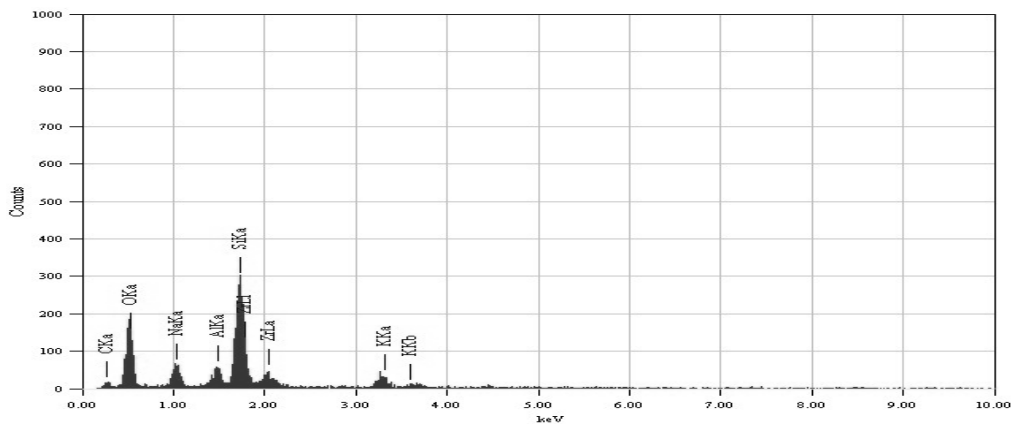
Graph :12 Energy Dispersive X-ray microanalysis of fractured interface of the core surface (Group IV)

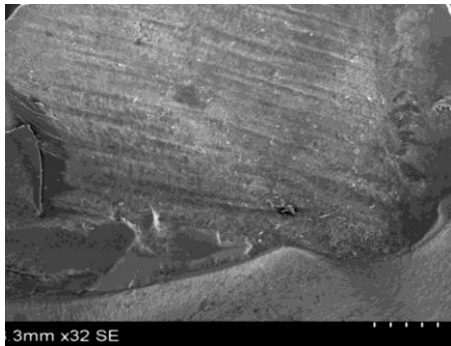
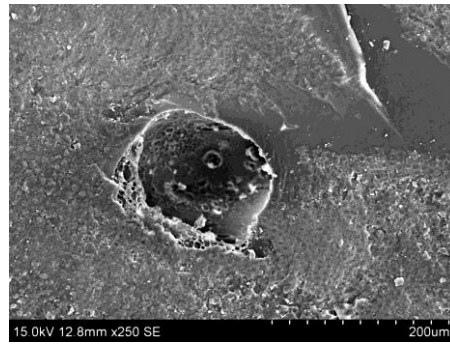
Fig. 37 c : Fractured veneer surface (Group IV), under 30x magnification

Fig. 37 d : Fractured veneer surface (Group IV),under 250x magnification

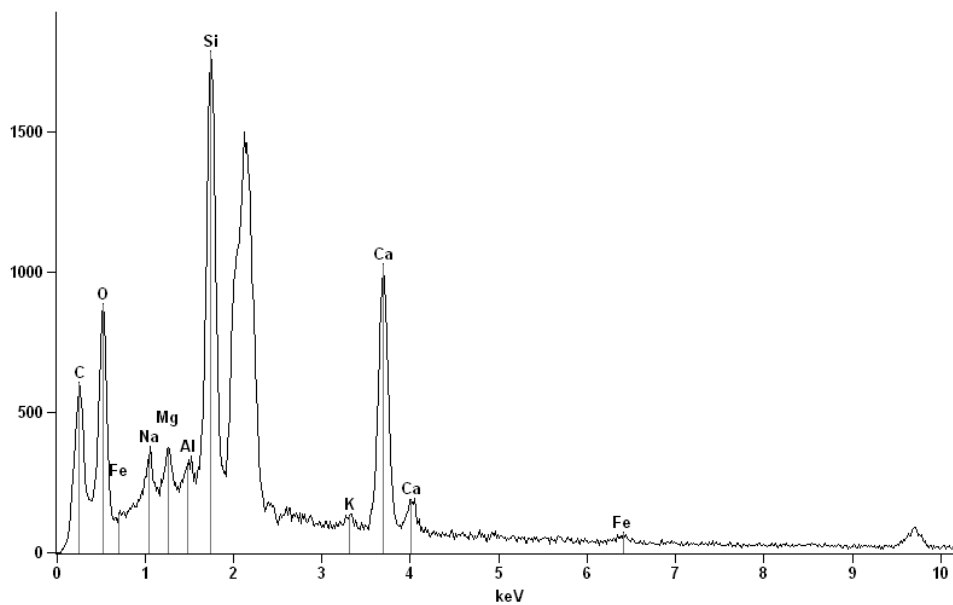
Graph :13 Energy Dispersive X– ray microanalysis of fractured veneer surface (Group IV)
